Structure Condition Inspection Report

Name A.J. Bond Bridge

Crossing Name Gilbert River

Date 01-OCT-2009

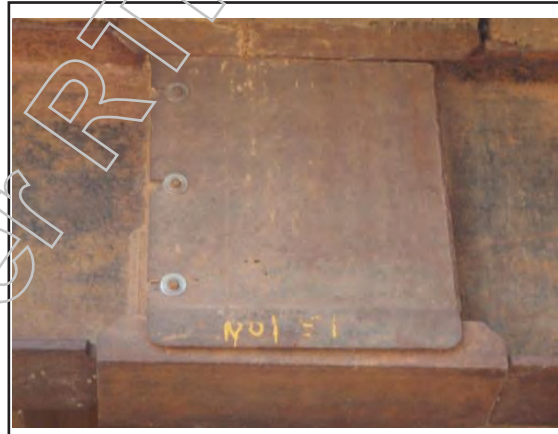
SHOWING REPLACED STUB BOLTS ON EXPANSION HINGE PLATE

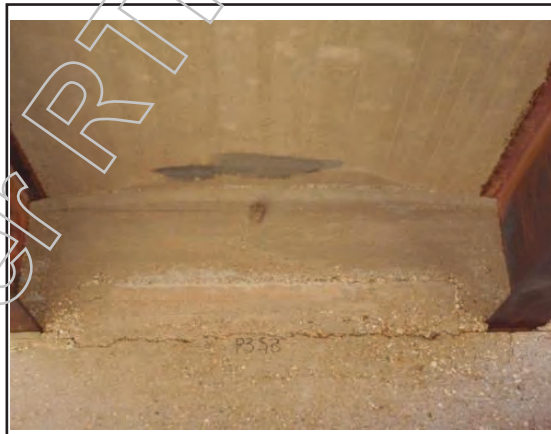
VIEW OF CRACK ALONG BOTTOM OF XG AND ENCASED BEARINGS

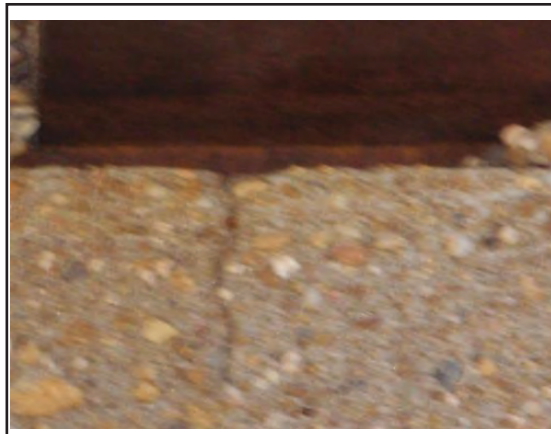
VIEW OF VERTICAL CRACK BELOW G2 SIDE 2

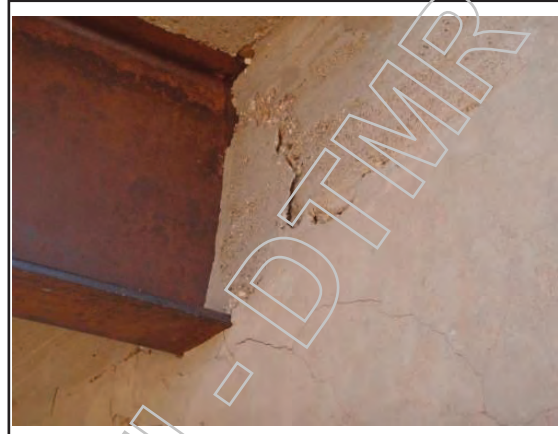
Description
VIEW OF SPALL ON ABUTMENT FACE ON OUTSIDE OF GIRDER 2 SIDE 2

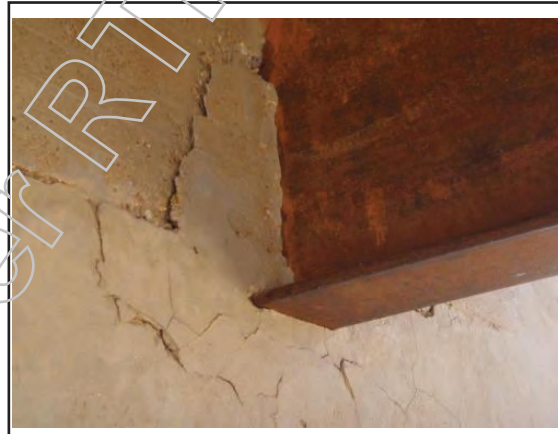
Description
VIEW OF SPALL ON ABUTMENT FACE ON INSIDE OF GIRDER 2 SIDE 2

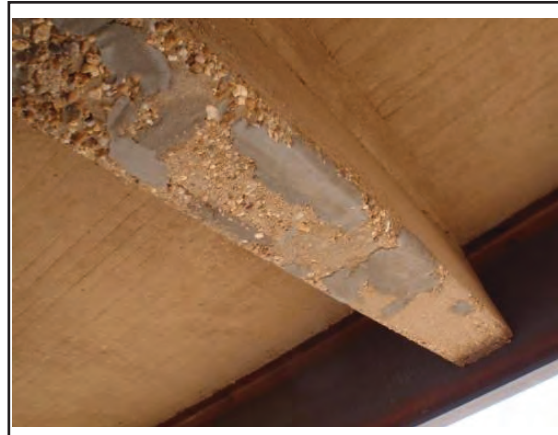
Description
SHOWING PATCHED XG

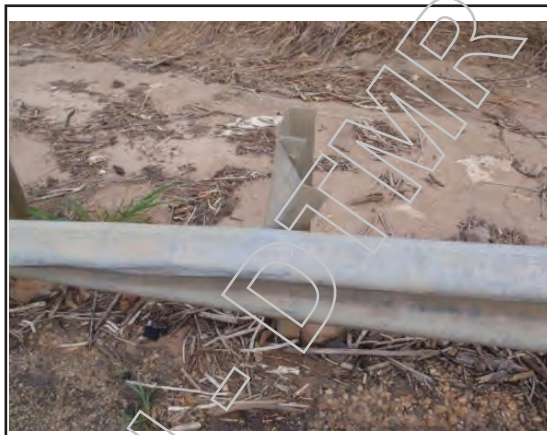
VIEW OF DAMAGED SPACER SIDE 2

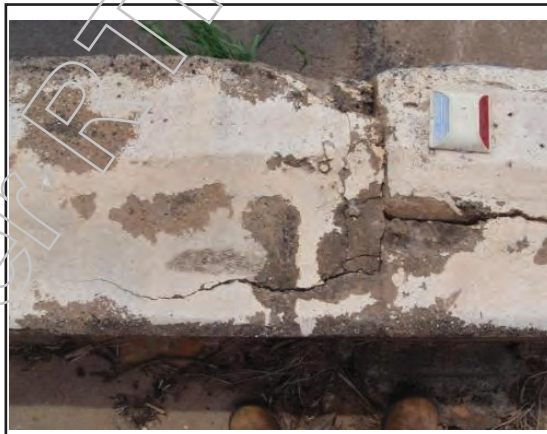
SHOWING CRACK ON APPROACH KERB TO SPAN 1 KERB SIDE 2.
