Technical Note 67

VMS Gantry Repair Procedure

August 2015

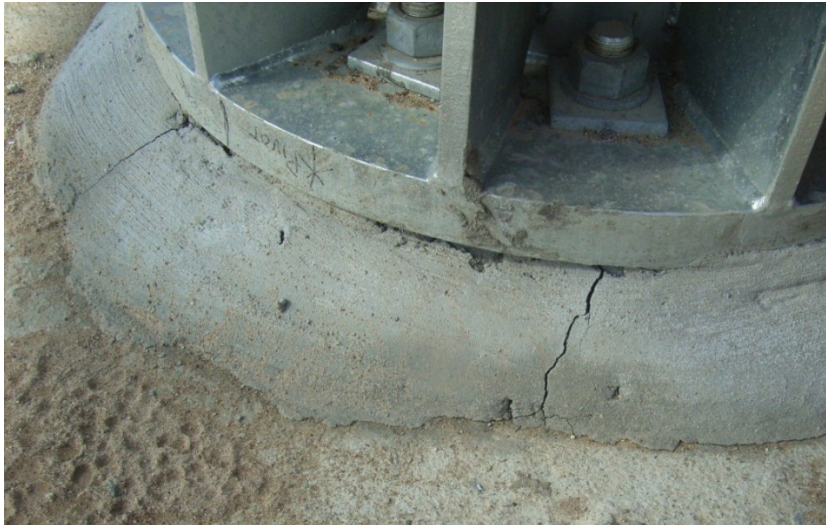
The design drawings state that mortar should be placed under the base plate and the base plate shall be fully supported on the mortar. The majority of the gantries have been placed on Levelling nuts. If the mortar has reflective cracking then the generally suggests that the mortar has only been placed around the perimeter. Refer to Figure 1. If the area is struck with a hammer, this will often verify if the mortar is sound. If the mortar is not sound then the effect shown in Figure 2 will occur. Figure 3 shows that the gantry has been landed on levelling nuts.

Figure 1 – Reflective cracking indicates the mortar is not sound

3.3 Repair process for base plate problems

The following checks must be carried out.

- Determine if the gantry is supported on levelling nuts;
- Determine if the mortar has been placed under the complete gantry base plate and the mortar in in contact with the base plate;
- Are any slotted holes clearly visible.

If either of these defects are found then follow the procedure below.

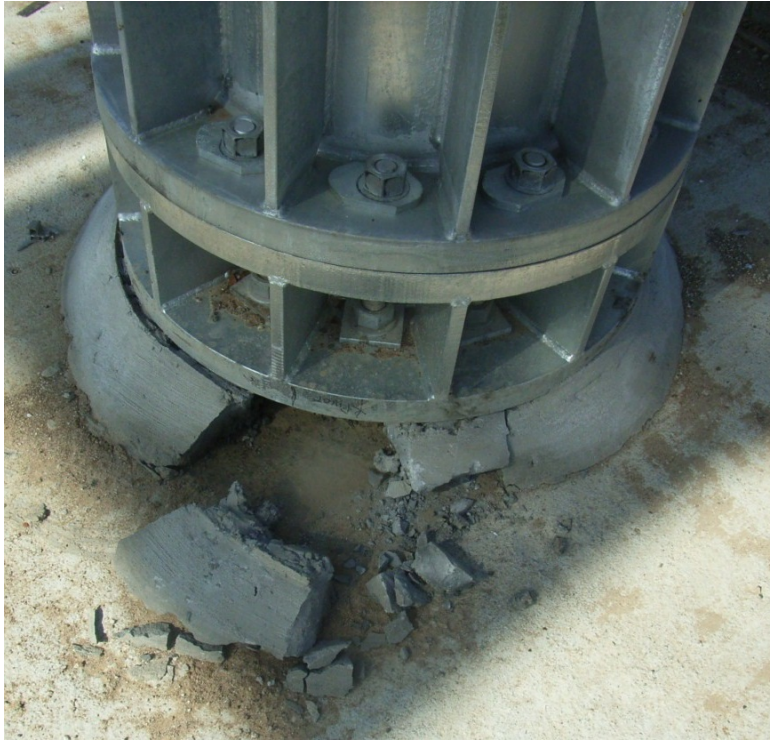
Figure 2 – Mortar only placed around the perimeter

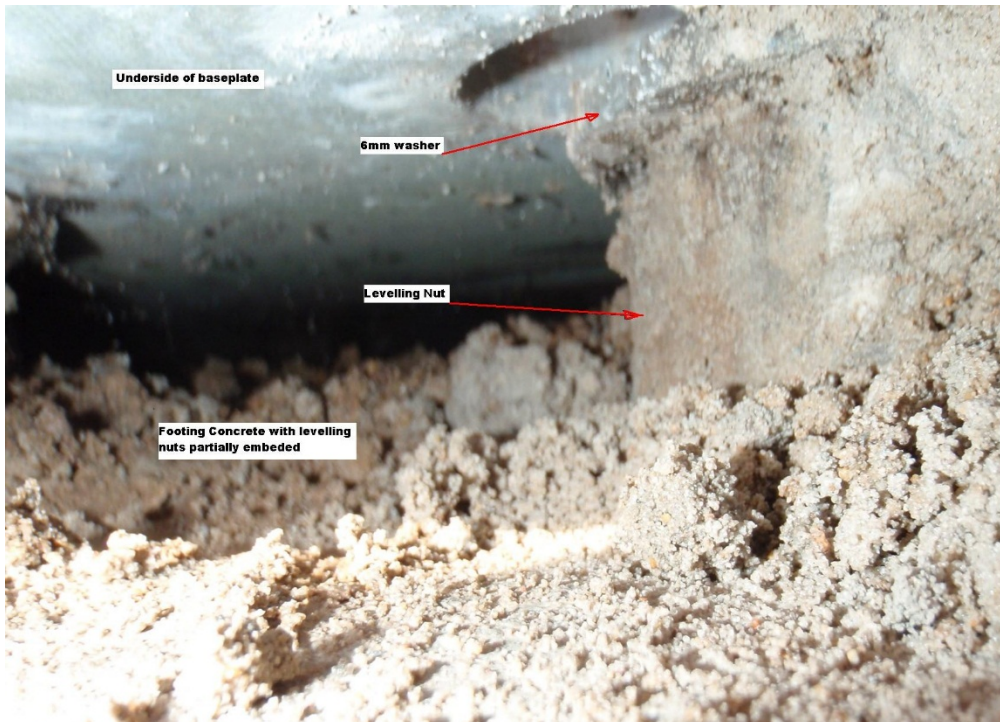
Figure 3 – View under the base plate

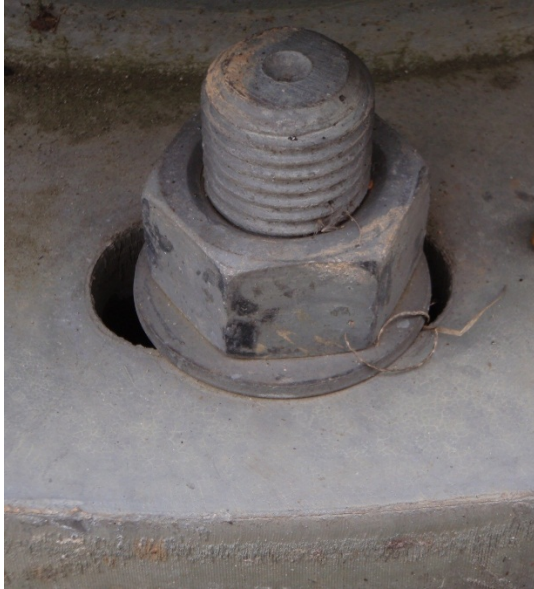
The next most common defect we find this the holding down bolt washers are starting to pull through the slotted holes in the base plate. Refer to Figure 4. The Australian Design Codes state that a plate shall be placed over the slotted holes to prevent the nut or bolt pulling through the slotted hole.

Figure 4 – Washer is pulling through the slotted hole

1. For the slotted holes, a steel plate will need to be installed which spans across the slotted holes;
2. Before installing the washers, ensure that there will still be a minimum of 3mm of thread above the top of the nut once the washer has been installed.
3. Remove holding down nut and install the plate washer as shown in Figure 17 and Figure 18. Re-install the normal washer and nut. Note: Only one nut is removed at any one time.

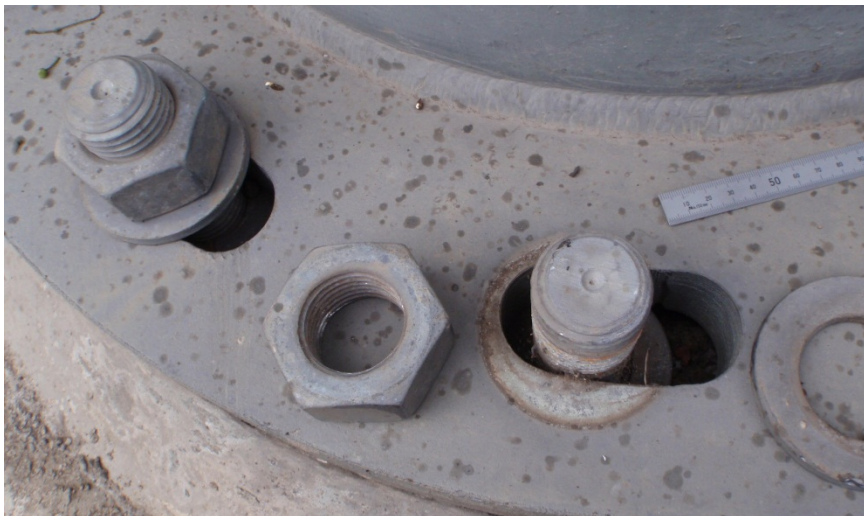
The other concern is in relation to the bolt tension. We have found some hold bolt nuts are loose. Refer to Figure 5. The way to identify if a nut is correctly installed is tap the hold down bolt with a hammer. The bolt should have a ringing sound.

Figure 5 – Hold down nut was loose

13. Repair the mortar where the wedges were placed with Conbextra GP mortar (or approved equivalent) to a trowable consistency;
14. Tension the hold down bolts until they are snug tight;

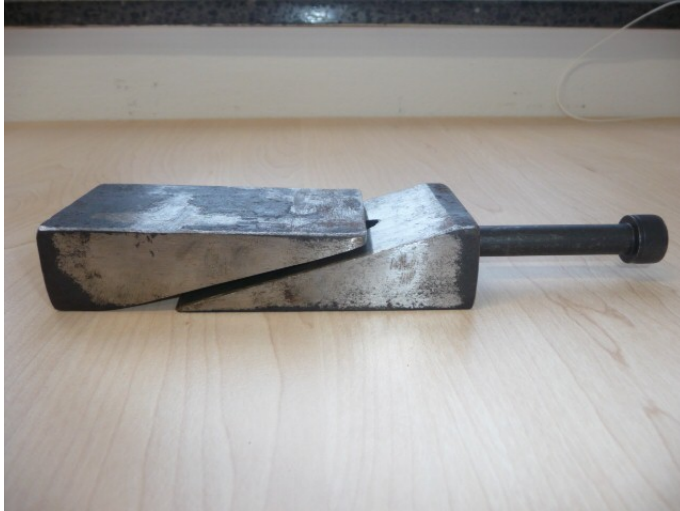
1. Obtain the steel wedges which will be used support the gantry column. Refer to Figure 6, Figure 7 and Figure 8;

Figure 6 – Steel Wedge

4. Place a thin layer of foam around the wedge.
5. Position 4 - steel wedges at 90o to one another. If extra packing is required, place the packers on top of the steel wedge.
6. Back off each levelling nut evenly until the gantry is supported on the steel wedges (Note: This process will need to be carried out slowly);
7. Glue 4mm timber dowels to the underside of the base plate. These dowels will ensure the gantry will effectively drain;
8. Place formwork around the base and ensure that formwork is water tight. Refer to Figure 10;

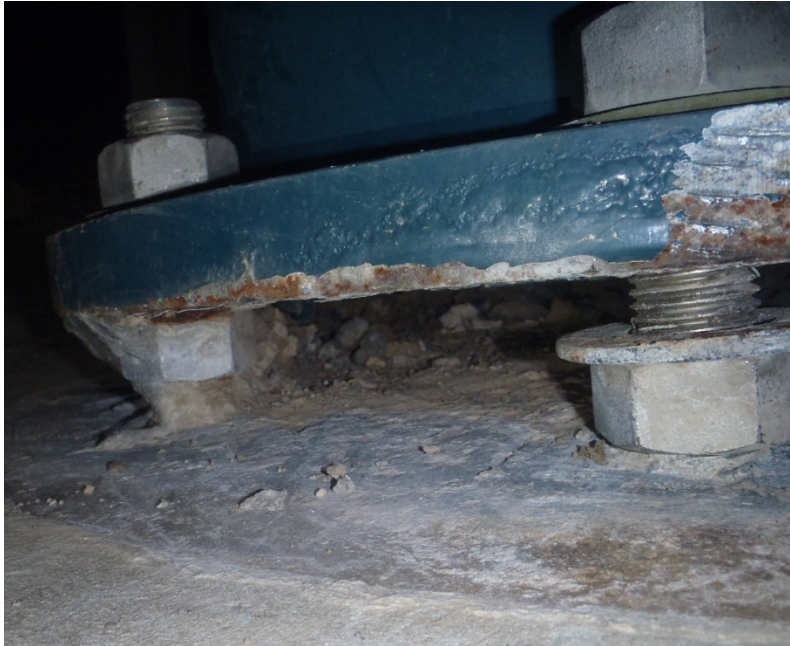
2. Remove all the existing unsound mortar, refer to Figure 9;

Figure 9 – View of the mortar removed from under the gantry

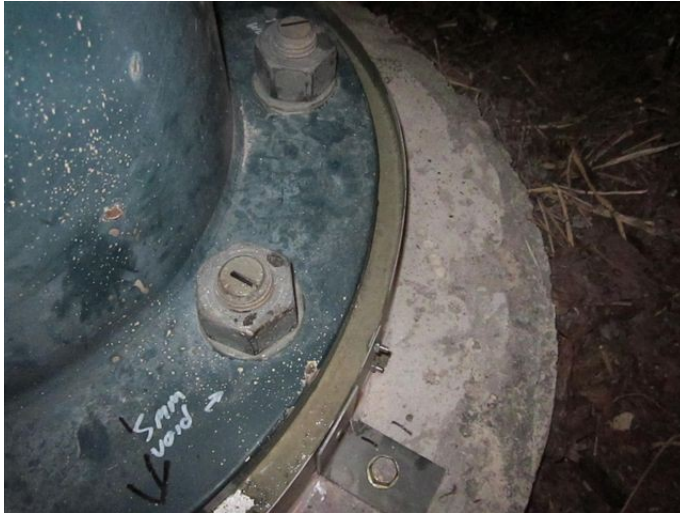
Figure 10 – View of the formwork placed around the footing

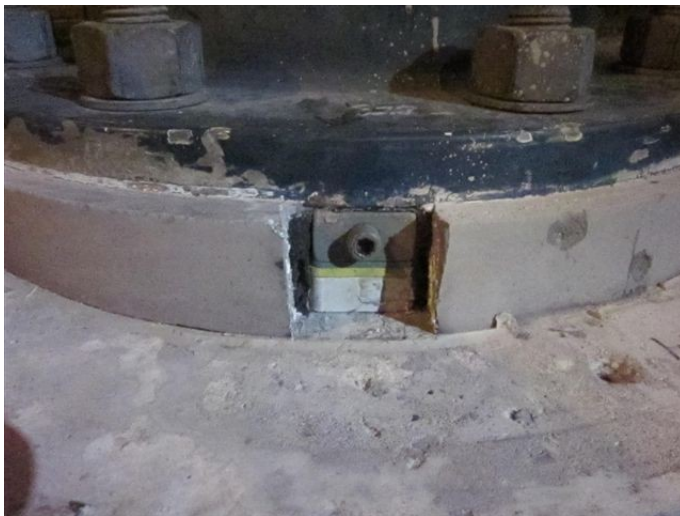
9. Mix up Conbextra GP mortar (or approved equivalent) to a flowable consistency;
10. Place the mortar so the mortar comes to the underside of the base plate;
11. Wait 24 hours for the mortar to achieve the required strength of 32MPa;
12. Remove the formwork, timber dowels and steel wedges from under the gantry, refer to Figure 11 and Figure 12;

Figure 11 – View of the mortar and installed wedge

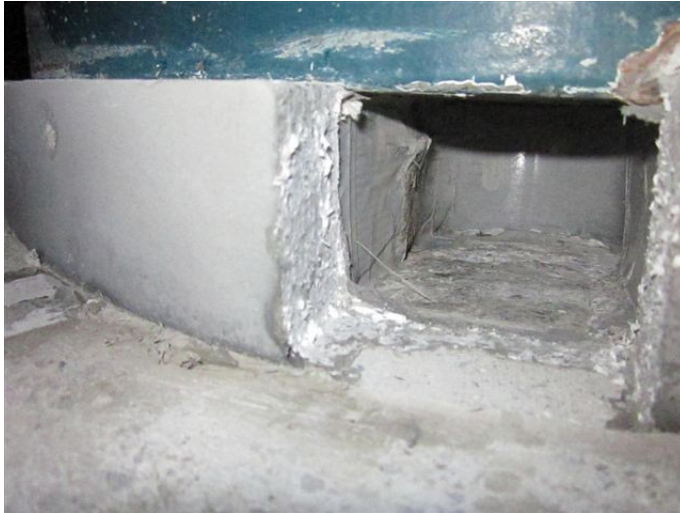
Figure 12 – View of the pocket created by the removed wedge

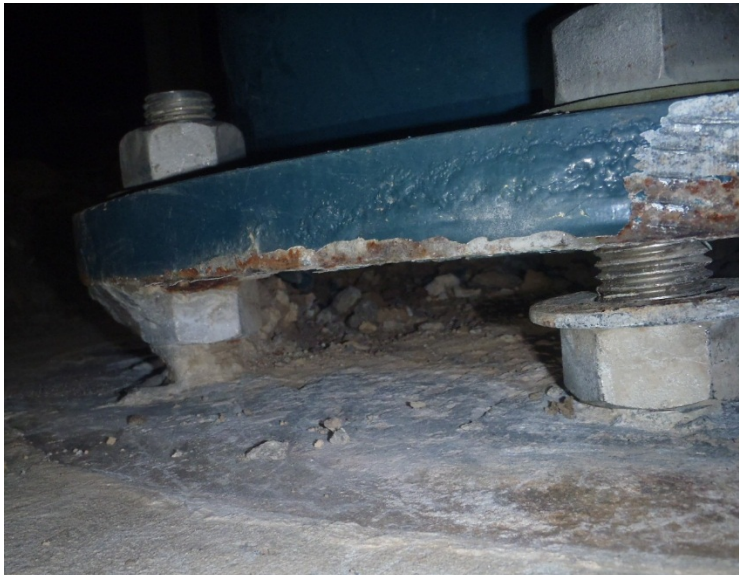
Figure 13 – View of the mortar removed from under the gantry

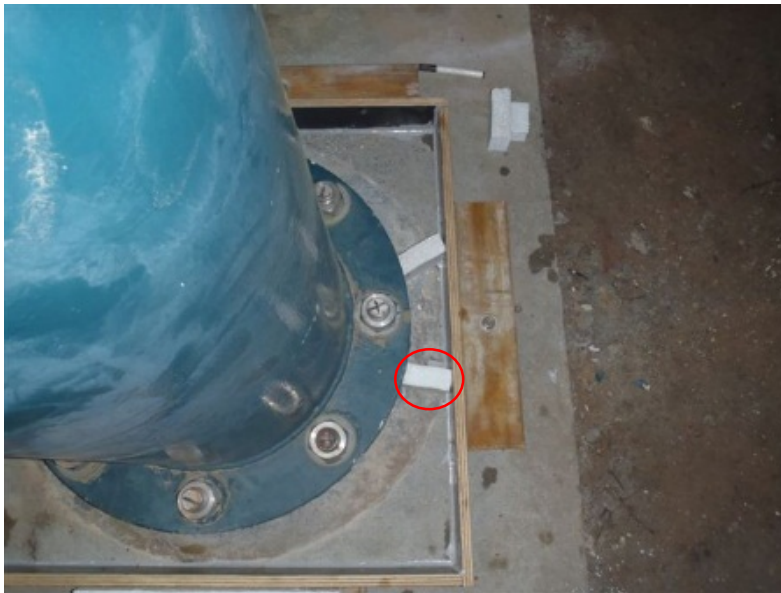
Figure 14 – View of the foam around the levelling nut

3. Place foam around the 4 of the levelling nuts, refer to Figure 14;
4. Back off each levelling nut evenly until the gantry is supported at the correct height (Note: This process will need to be carried out slowly);
5. Glue 4mm timber dowels to the underside of the base plate. These dowels will ensure the gantry will effectively drain.
6. Back off all the other nuts which are not encapsulated within the foam;
7. Place formwork around the base and ensure that formwork is water tight;
8. Mix up Conbextra GP mortar (or approved equivalent) to a flowable consistency;
9. Place the mortar so the mortar comes to the underside of the base plate;
10. Wait 24 hours for the mortar to achieve the required strength of 32MPa;
11. Remove the formwork and timber dowels;

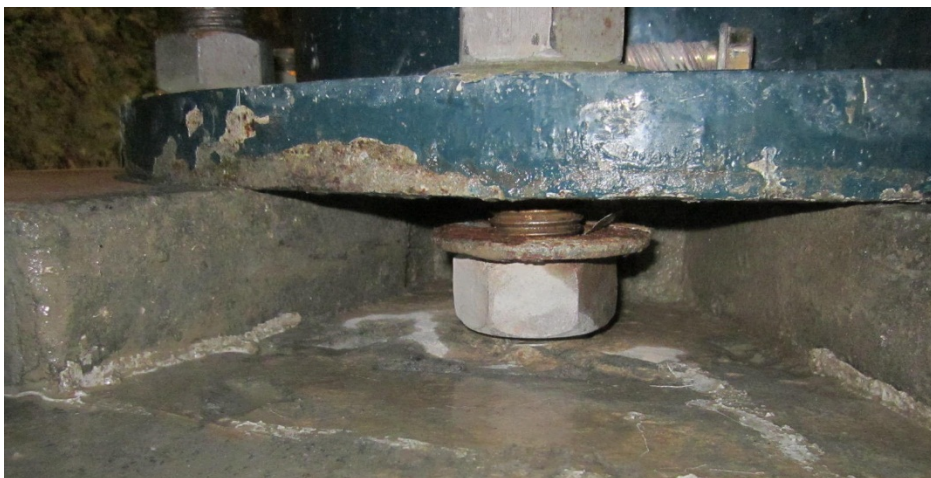
Figure 15 – View of the mortar and installed wedge

12. Back of the levelling nuts, so the gantry is supported on the mortar, refer to Figure 15;
13. Place formwork around the base and ensure that formwork is water tight;
14. Mix up Conbextra GP mortar (or approved equivalent) to a flowable consistency;
15. Place the mortar in the area where the levelling nuts were backed off. Ensure the mortar comes to the underside of the base plate, refer to Figure 16;
16. Tension the hold down bolts until they are snug tight;

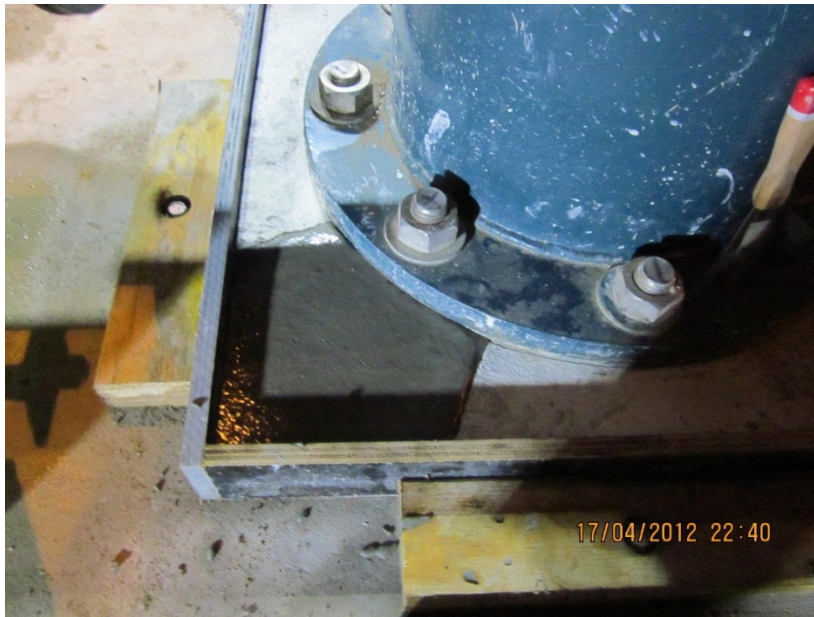
Figure 16 – View of the pocket created by the removed wedge

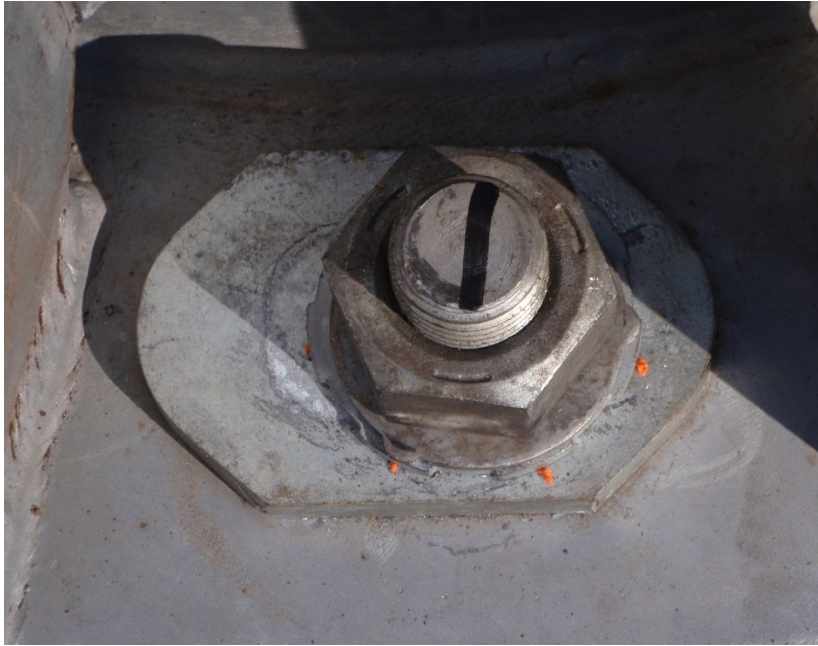
Figure 18 – View of an installed plate washer

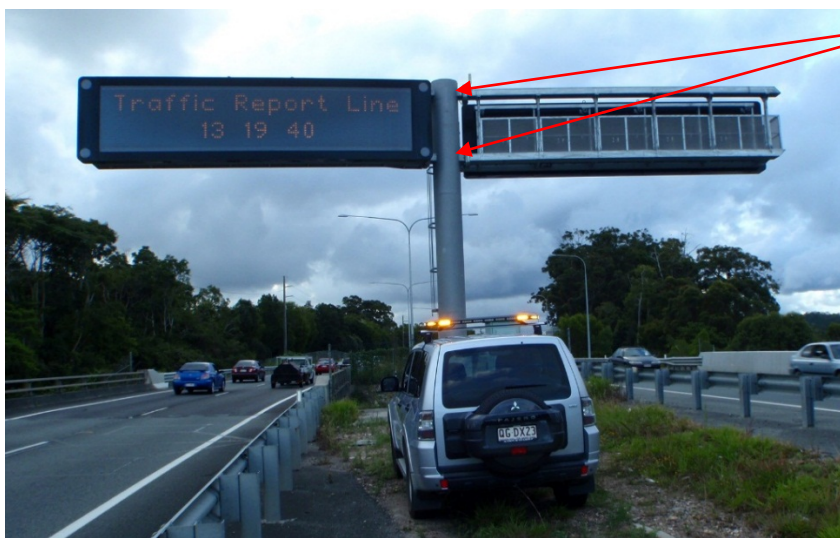
During routine Level 2 LTMS inspections, a number of splice joints were identified with gaps between the splice plates. Figure 19 shows the location of the splice joint and Figure 20 shows the state of some of the splice bolts. Some of the splice joints have not been pulled together, as there is clear gaps between the splice plates. Refer to Figure 21.

Figure 19 – View of the splice joint location

Splice Joint

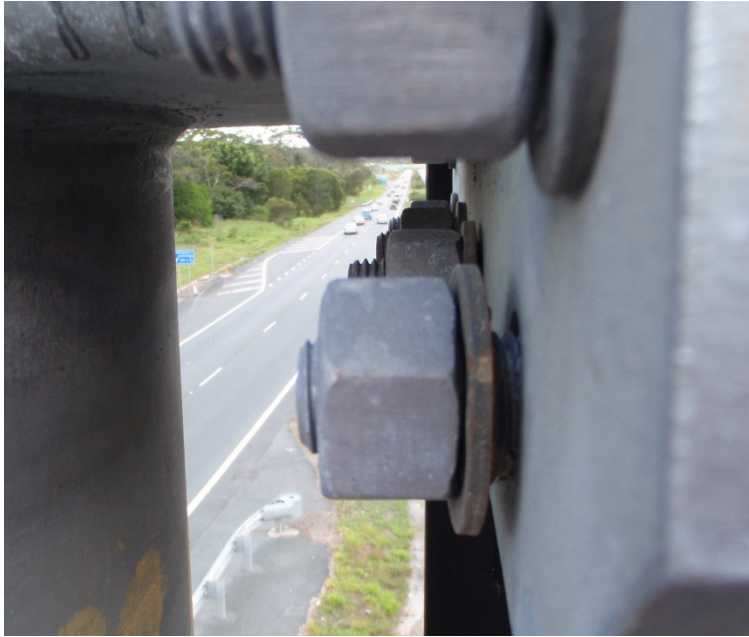
During the inspection of the VMS gantries we have found that the splice joints bolts have not been tensioned correctly.

Figure 20 – Some of the bolts have not been tensioned correctly

1. Measure the gap between the splice joint plates;
2. Place an 800mm long breaker bar on the existing splice bolts and determine if the bolts can still be tightened. (If the bolt moves the splice bolts were never tensioned correctly in the first instance);
3. If the measured gap is less than 4mm, then following Option A. If the measured gap is greater than 4mm, then follow Option B.

1. Using the bolt replacement sequence shown in Figure 25, remove the existing bolt and install a new bolt assembly. Ensure the load indicating washer flat surface is placed against the steelwork and there a washer between the nut and the load indicating washer. Ensure the bolt assembly is snug tight before moving to the next bolt;
2. Repeat Steps 1 until all the new bolts have been installed and the bolts are snug tight.
3. Once all the bolts have been replaced, then tension the bolts with a calibrated wrench as per TMR technical note TN62A;
4. Once all the bolt tensioning is complete, measure the gap between the splice joints with a 0.5mm feeler gauge to confirm the gap between the splice plates has closed up;
5. Ensure the first bolts have not lost any tension. (Bolt is loose or there is a gap between the load indicating washer);
6. Repeat the same process for the second splice joint.

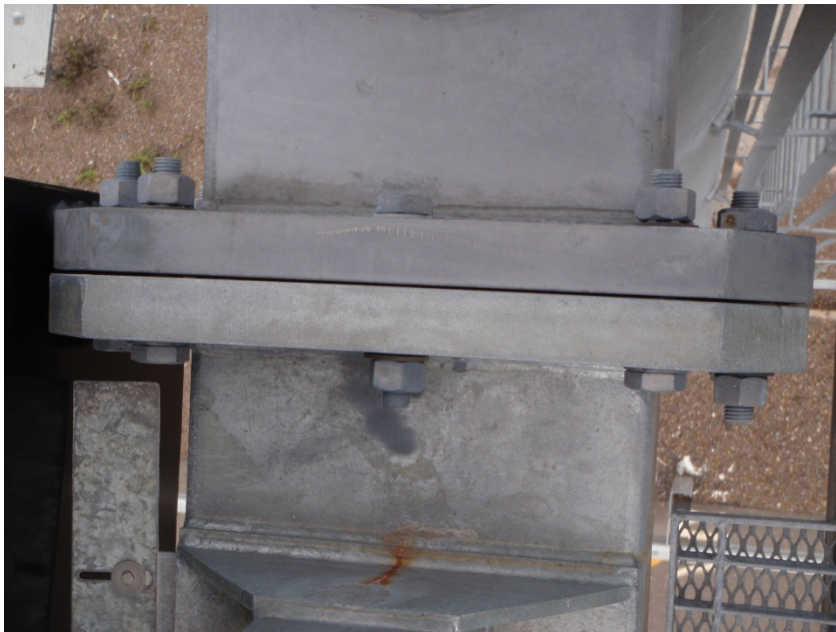
In the majority of cases a 1mm thick steel ruler can be slide between the splice joints. The joints were originally designed as a T/B connection, which AS 4100 requires the splice joints to have minimum contact surface of 67% of the splice area.

Figure 21 – Splice joint not pulled together

For this option, shim plates will be installed as the gaps between the place joint is greater than 2mm wide.

1. Measure the gap between the splice joint at each bolt location. This will determine the thickness of shim that should be installed. The largest gap will determine the thickness shim required for the joint;
2. The load of the cantilever section will need to be taken up with a 20 tonne Franner crane, so the shims can be installed;
3. Loosen all the splice bolts so the appropriate shims can be installed;

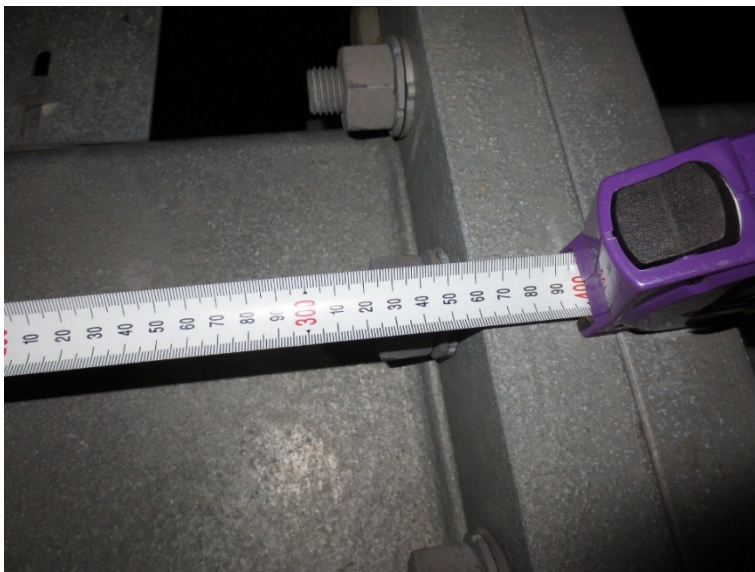
3. Fabricate the Spacer Washers as per Figure 22
4. Hire a tension wrench which has a maximum torque of 2000Nm. Ensure the tension wrench has an overall length of 300mm, refer to Figure 23;

Figure 23 – View of the distance available from the first vertical member to the splice joint

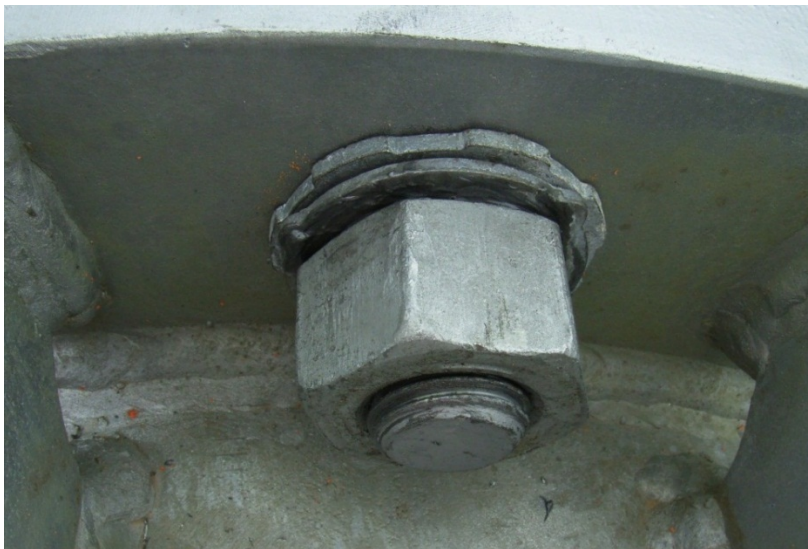
Figure 24 – Correct Installation

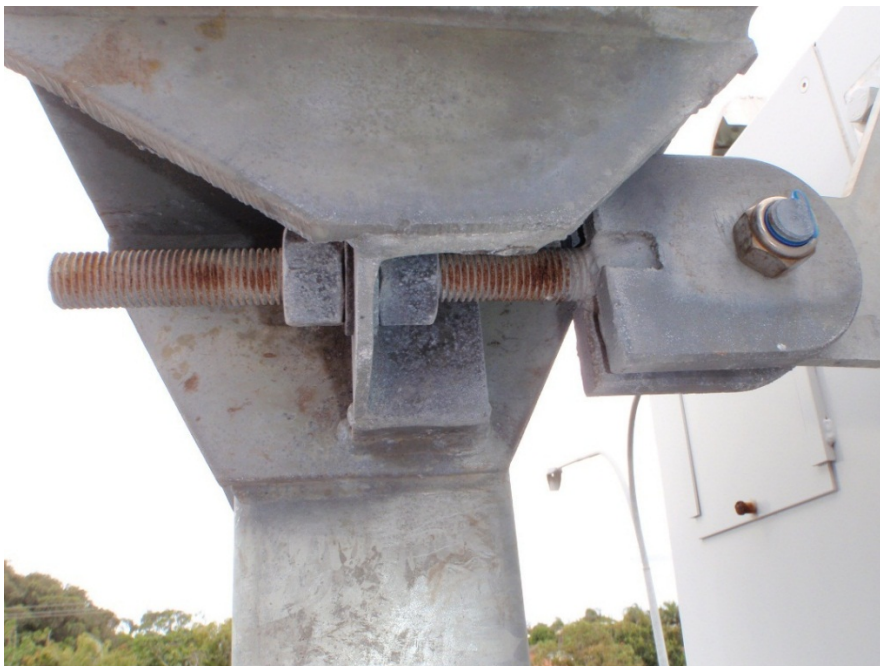
The clevis brackets are used support the VMS sign. In many cases the bracket has been poorly fabricated, as the welding around plate to the threaded rod is poorly executed, refer to Figure 26, Figure 27 and Figure 28

Figure 26 – View of the poorly fabricated clevis bracket

1. Remove the bolt connecting the existing clevis bracket to the gantry;
2. Cut the threaded section between the gantry vertical member and the clevis bracket;
3. Remove the threaded rod from the vertical member and the existing clevis bracket;
4. Bolt the new clevis bracket to the sign face, refer to Figure 32, Figure 33 and Figure 34;
5. Slide the new threaded rod through the hole in the gantry vertical member, ensuring the two locking nuts are installed;
6. Screw the threaded rod into the clevis bracket and ensure the threaded rod is screwed all the way into the clevis bracket;
7. Tighten the lock nut against the clevis bracket;
8. Tighten the nut on the back of the clevis assembly, so the clevis assembly is tight;
9. Tighten both lock nuts;
10. Repeat for the other clevis bracket.

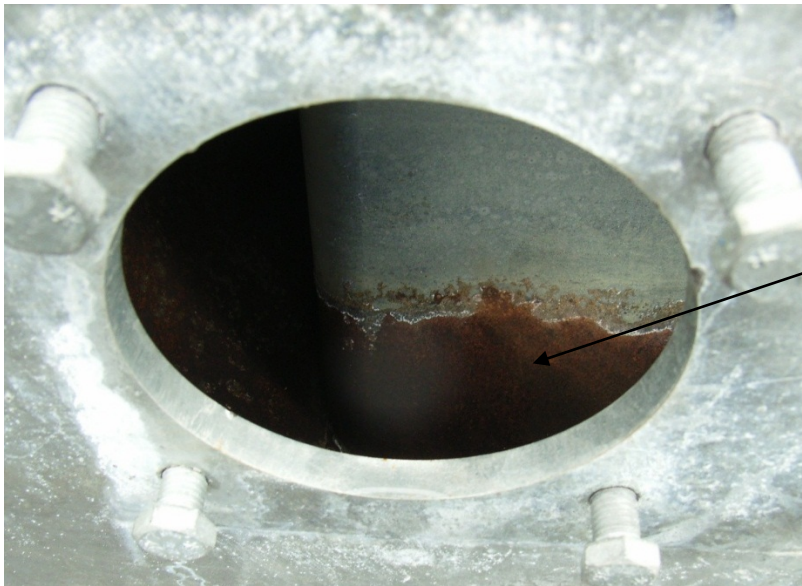
Figure 36 – View of the corrosion on the inside of the member

Corrosion caused by inadequate venting

If corrosion is found on the inside a member as shown in Figure 36, Figure 37, Figure 38, Figure 39 and Figure 40, then the following process will need to be used.

2. Remove the sign face, wiring and items which can be unbolted;
3. Ensure the structure is modified so the gantry members have adequate venting before the full structure is re- galvanised to the requirements of AS/NZS 4680. The best way to rectify the problem is to place a vent hole in the cap plate. Refer to Figure 44 or Figure 45.
4. Once the galvanising has been completed and inspect the gantry to ensure that the galvanising complies with the requirements of AS/NZS 4680;
5. Re-install the unbolted items, sign face and wiring;
6. Re-install the member.

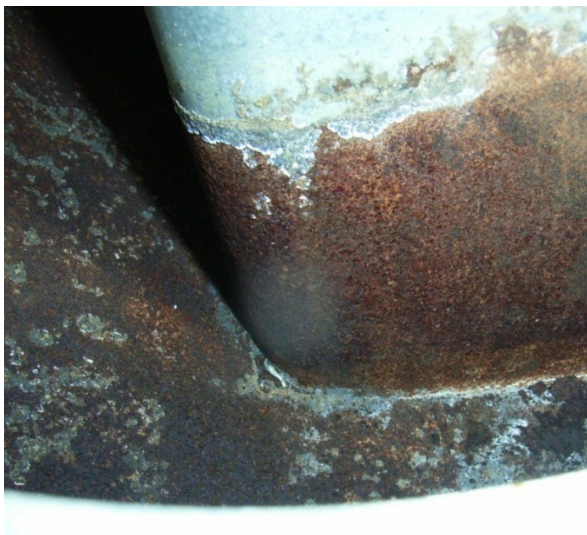
Figure 37 – Close up view of the corrosion

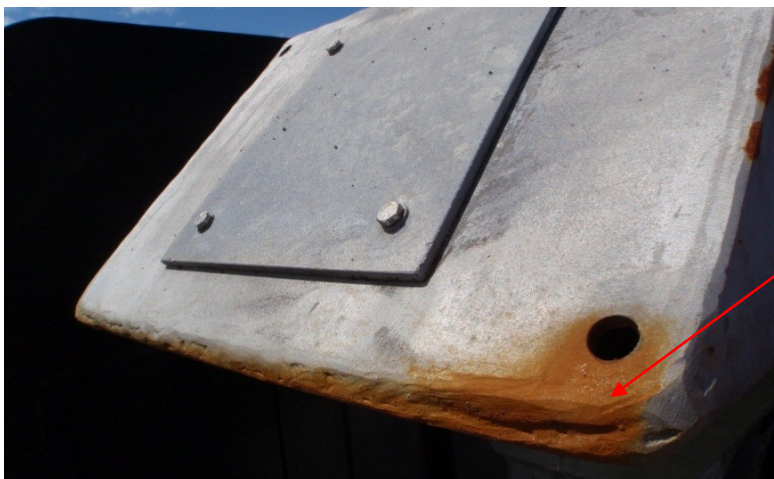
Figure 38 – Corrosion leaching out of vent hole

This defect indicates that the member is not galvanised on the inside of the member.

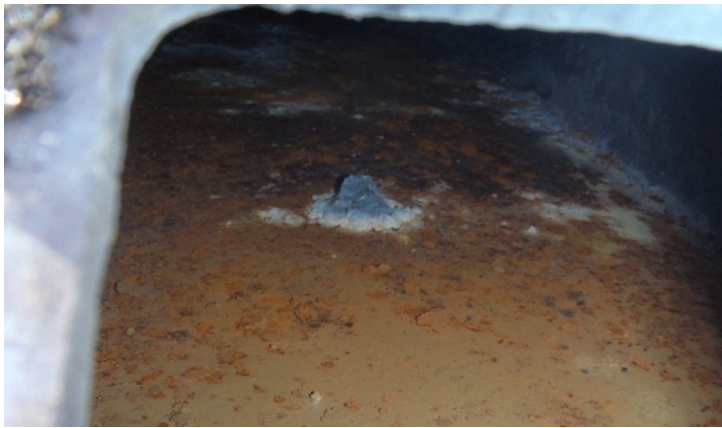
Figure 39 – View of the lack of zinc coating on the inside of the top member

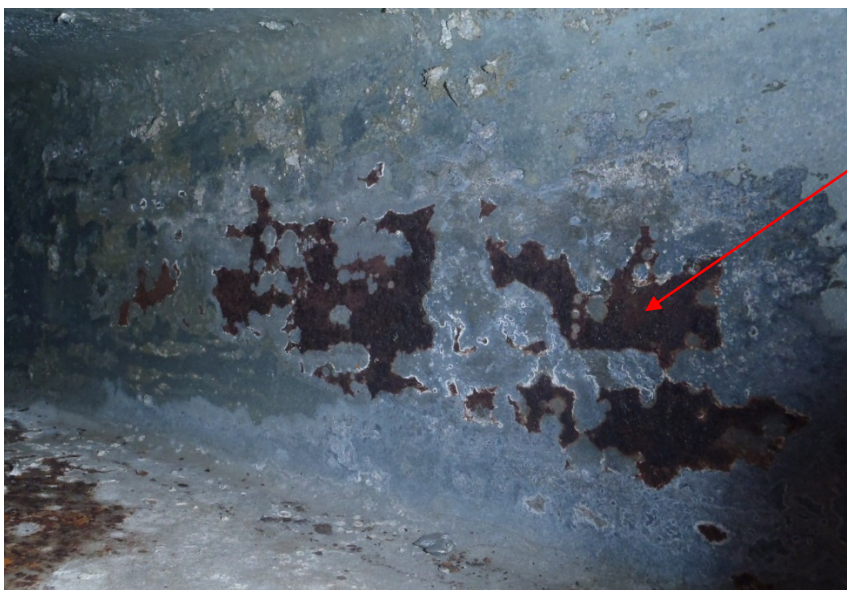
Figure 40 – View of the lack of zinc coating on the inside of the top member

Corrosion due to a lack of pre-flux in the galvanising process

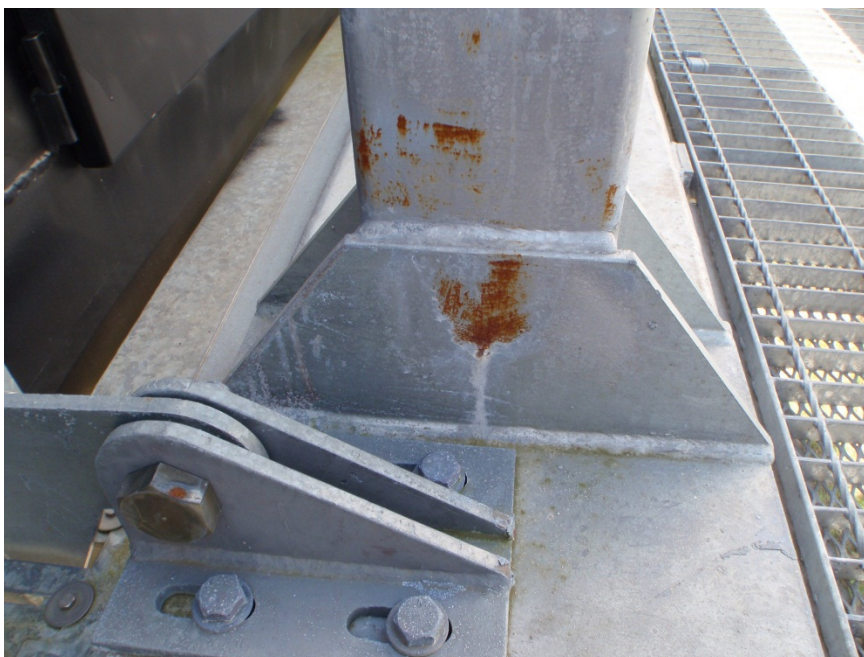
Figure 41 – Corrosion from the vent hole

1. Remove the surface corrosion with a wire brush;
2. Plug the venting hole with a lead sinker to seal off the vent hole;
3. Apply two coats of Jotun Galvanite (or approved equivalent) by brush.

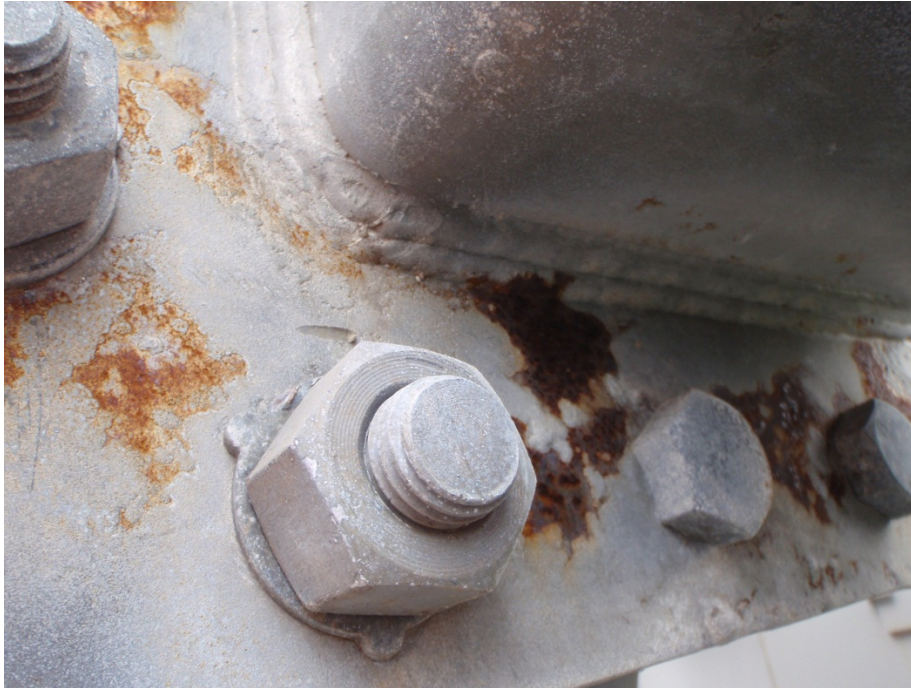
Figure 42 – General corrosion

For general spot corrosion as shown in Figure 42 and Figure 43, the following process shall be used.

1. Remove the surface corrosion with a wire brush;
2. Apply two coats of Jotun Galvanite (or approved equivalent) by brush.

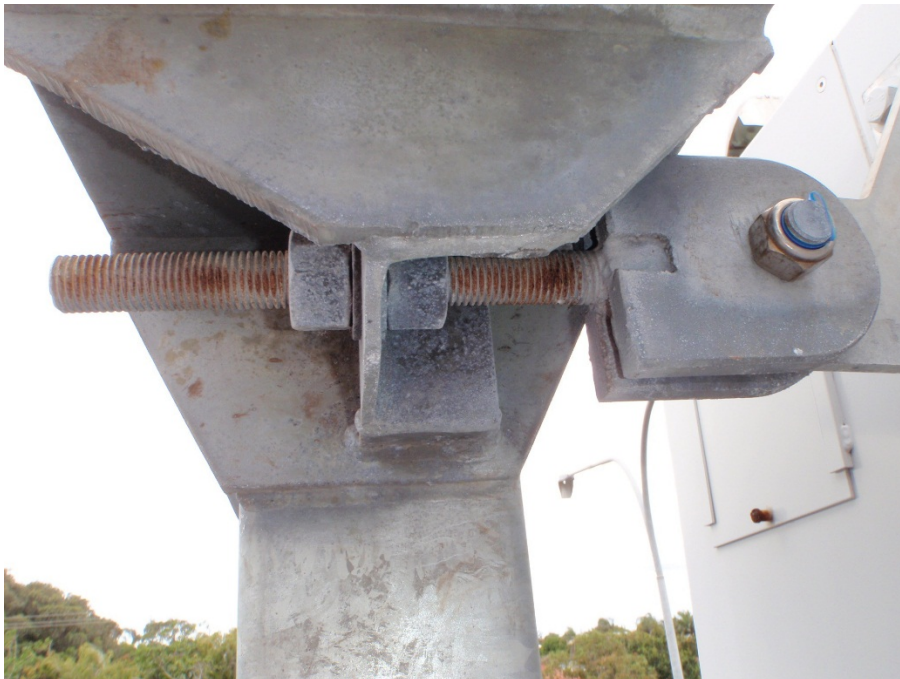
Figure 43 – General corrosion on the threads

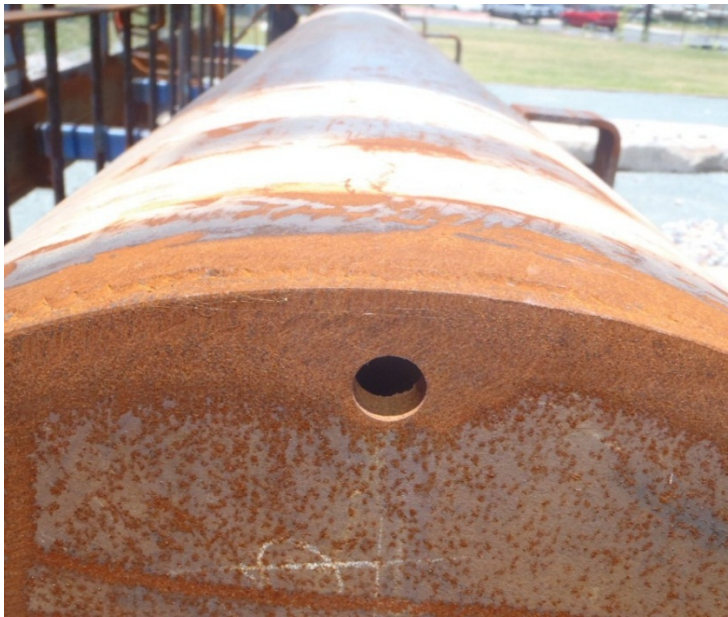
Figure 44 – Provide a means for the air to escape

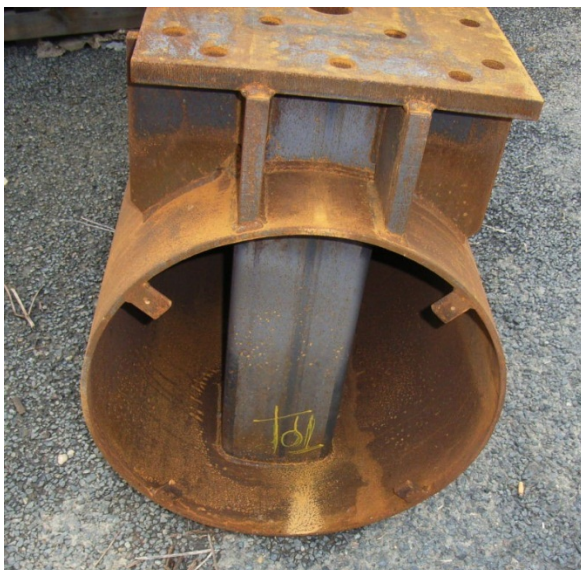
Figure 45 – One way to provide adequate venting is to bolt on the cap plate

Another option is to bolt the cap plate onto the top of the column. Refer to Figure 45. Note: If the bolt on cap plate is used the gantry designers will need to confirm the can be undertaken.

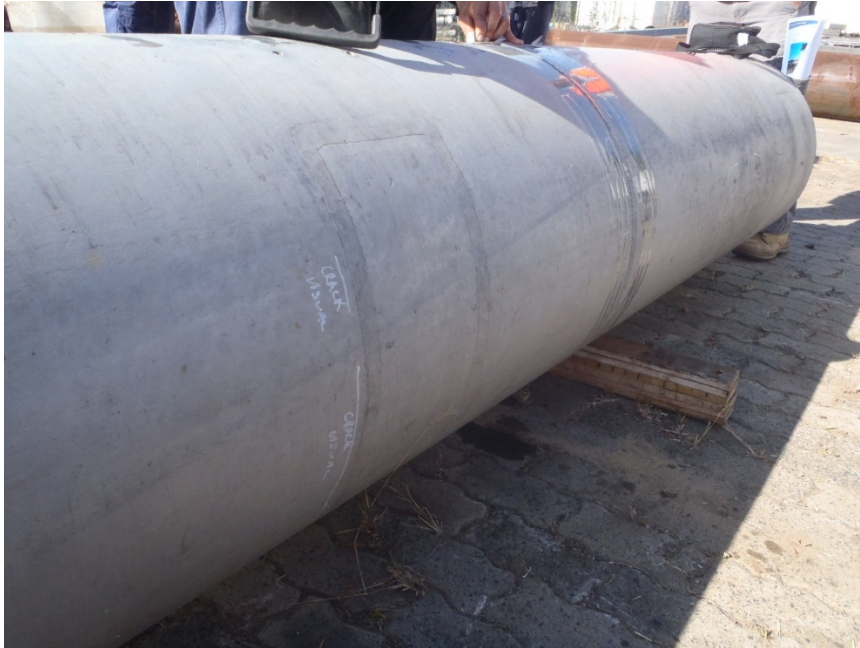
During routine inspections we have found some welds have weld defect or cracks. Refer to Figure 47 and Figure 48. When this defect is found Structural Engineering advice may be required to provide a method of repairing the structure.

Figure 47 – View of the column member inspected

1. The gantry structure will need to be taken down and sent to a TMR approved fabricator for repair;
2. The galvanising coating will need to be stripped off the gantry member before the defect can be repair;
3. Grind out the weld defect and replace the weld to the requirement of MRTS78;
4. Carry out 100% ultrasonic testing to determine if the weld defect has been rectified;
5. Once welding is complete, the gantry structure will be sent for galvanising;
6. Re-install the gantry structure.

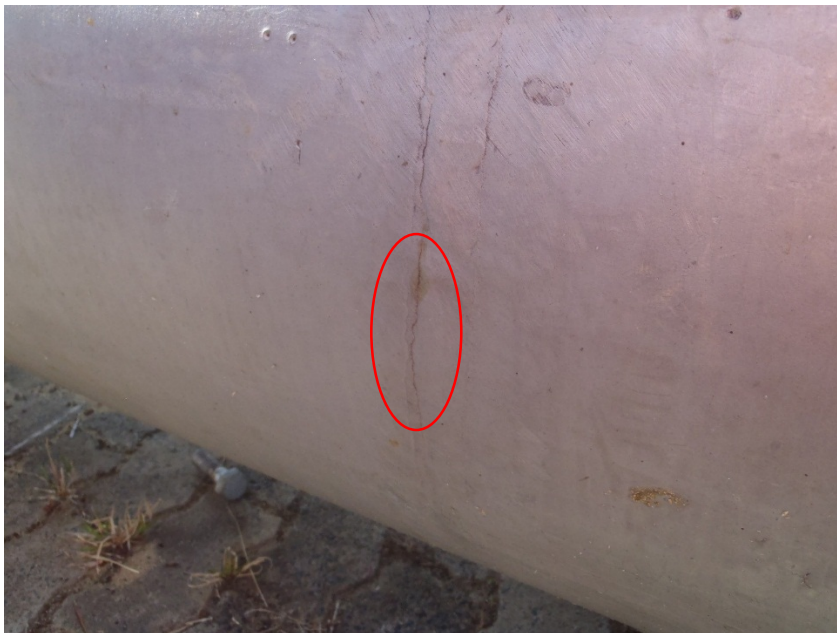
Figure 48 – View of the visual cracks in the butt weld on the back side of the column member

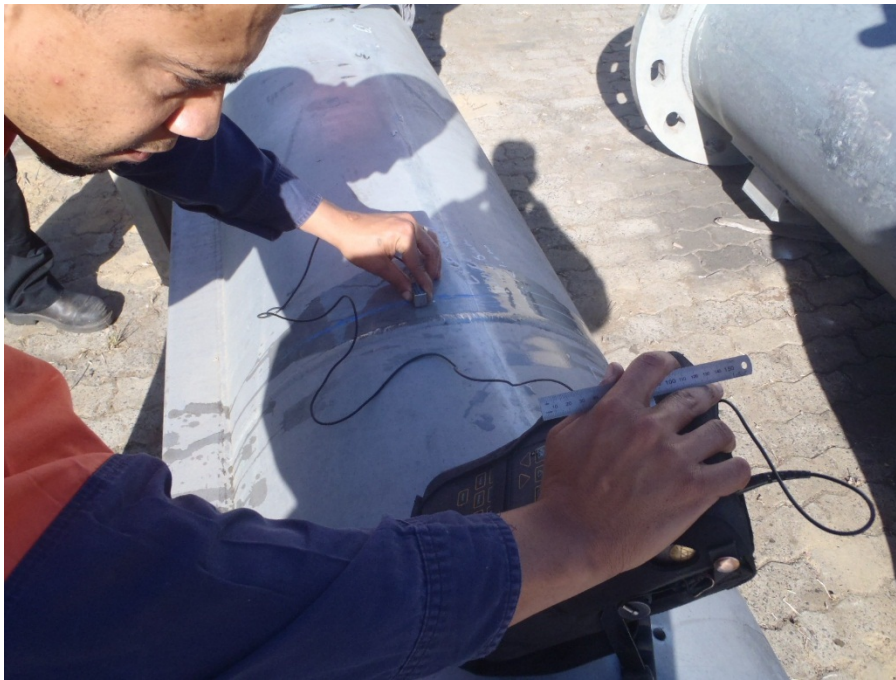
1. Carry out 100% Ultrasonic testing of the member to determine the extent of the defect. This work is performed by specialist Non Destructive Testing (NDT) companies. Refer to Figure 49. (Note: NDT of galvanised steelwork is usually not permitted. However the testing will give an indication of the defects that may exist in a structure.)

Figure 49 – View of the method of testing the welds

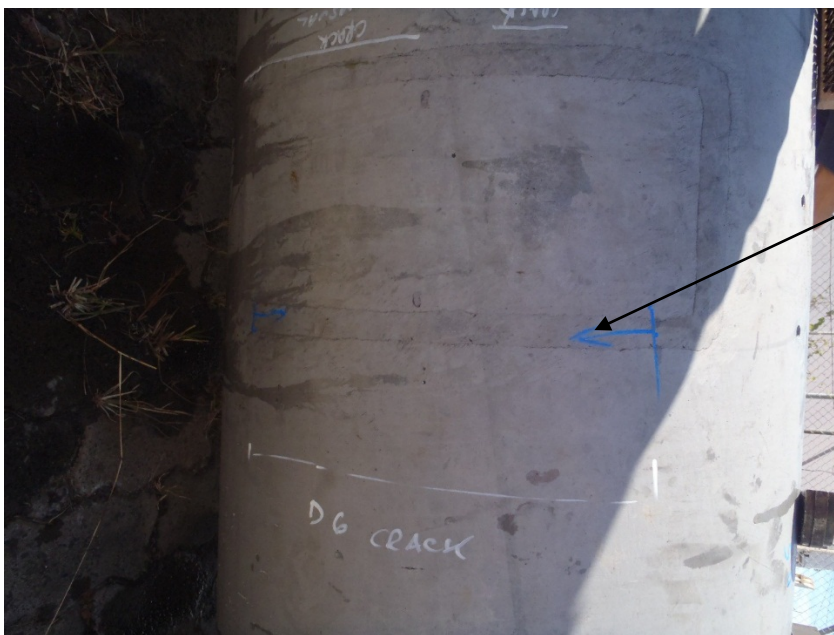
2. If the NDT detects any defects which are not visible, they will be marked out on the member. Refer to Figure 50, Figure 51 and Figure 52.

Figure 50 – View of the marked out area

View of the cracked area which is not clearly visible

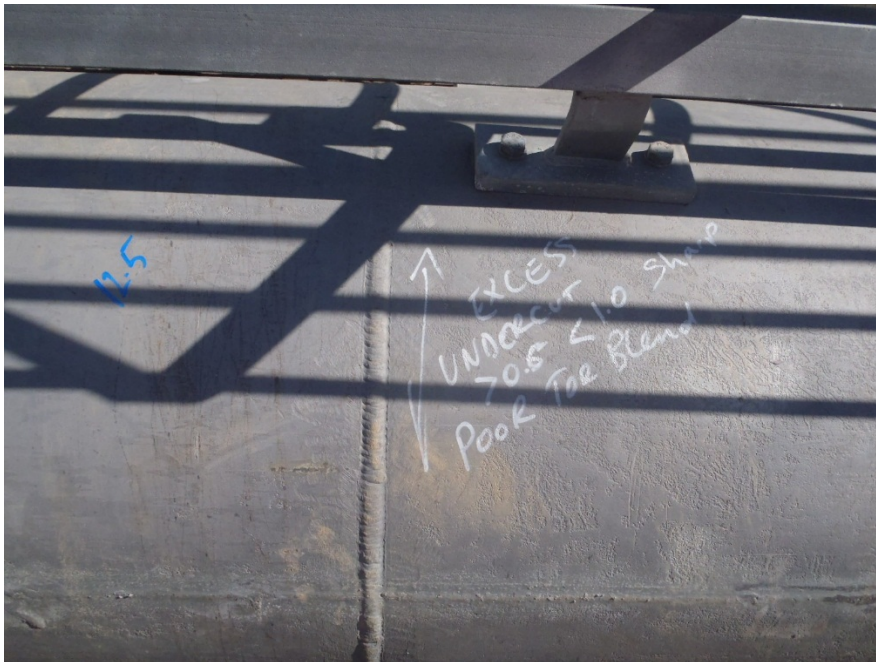
Figure 51 – View of the full circumferential weld in the column member

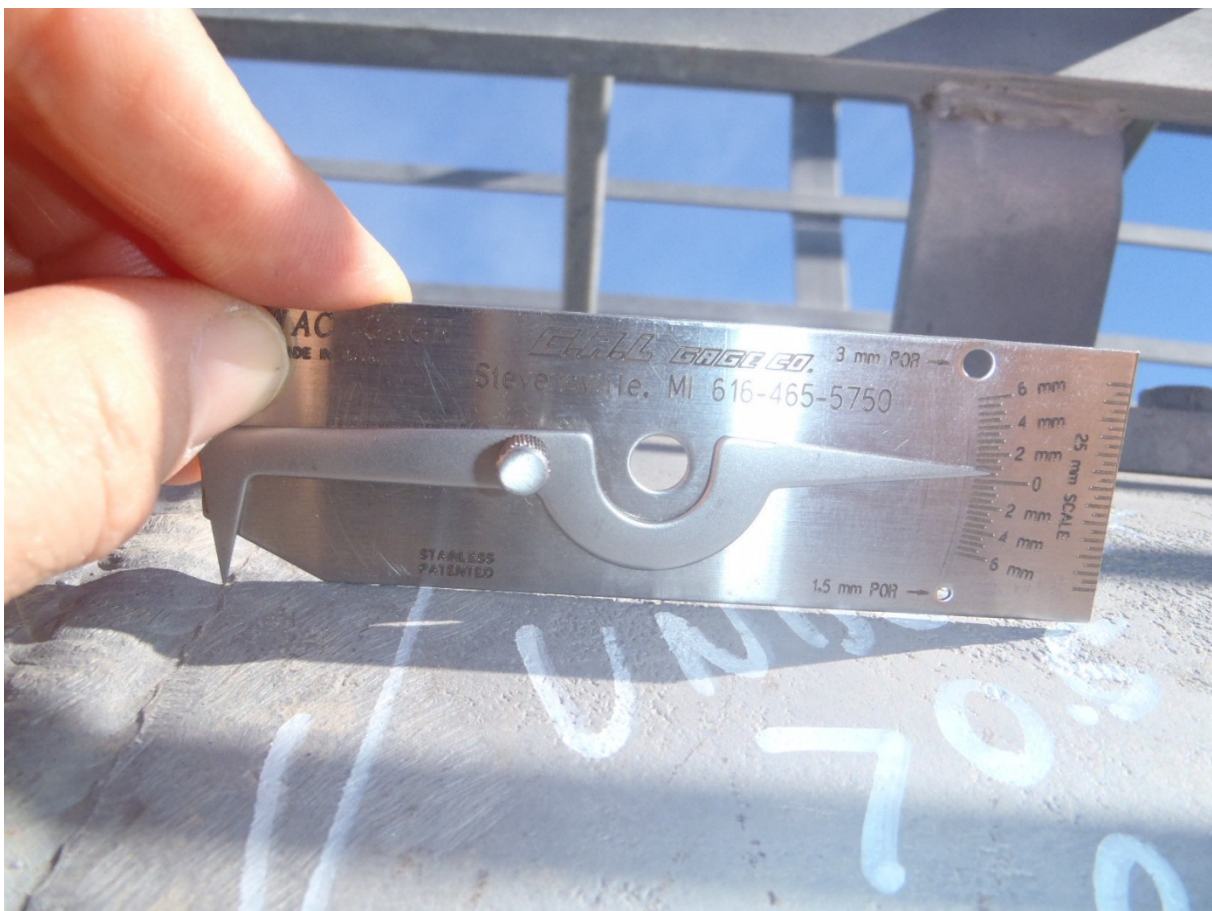
Figure 52 – View of the level of undercut in the butt weld
