# Fauna sensitive infrastructure investment opportunities on the Nebo to Eton stretch of the Peak Downs Highway, Central Queensland.

A report to the Queensland Department of Transport and Main Roads

November 2018

Koala Research CQ

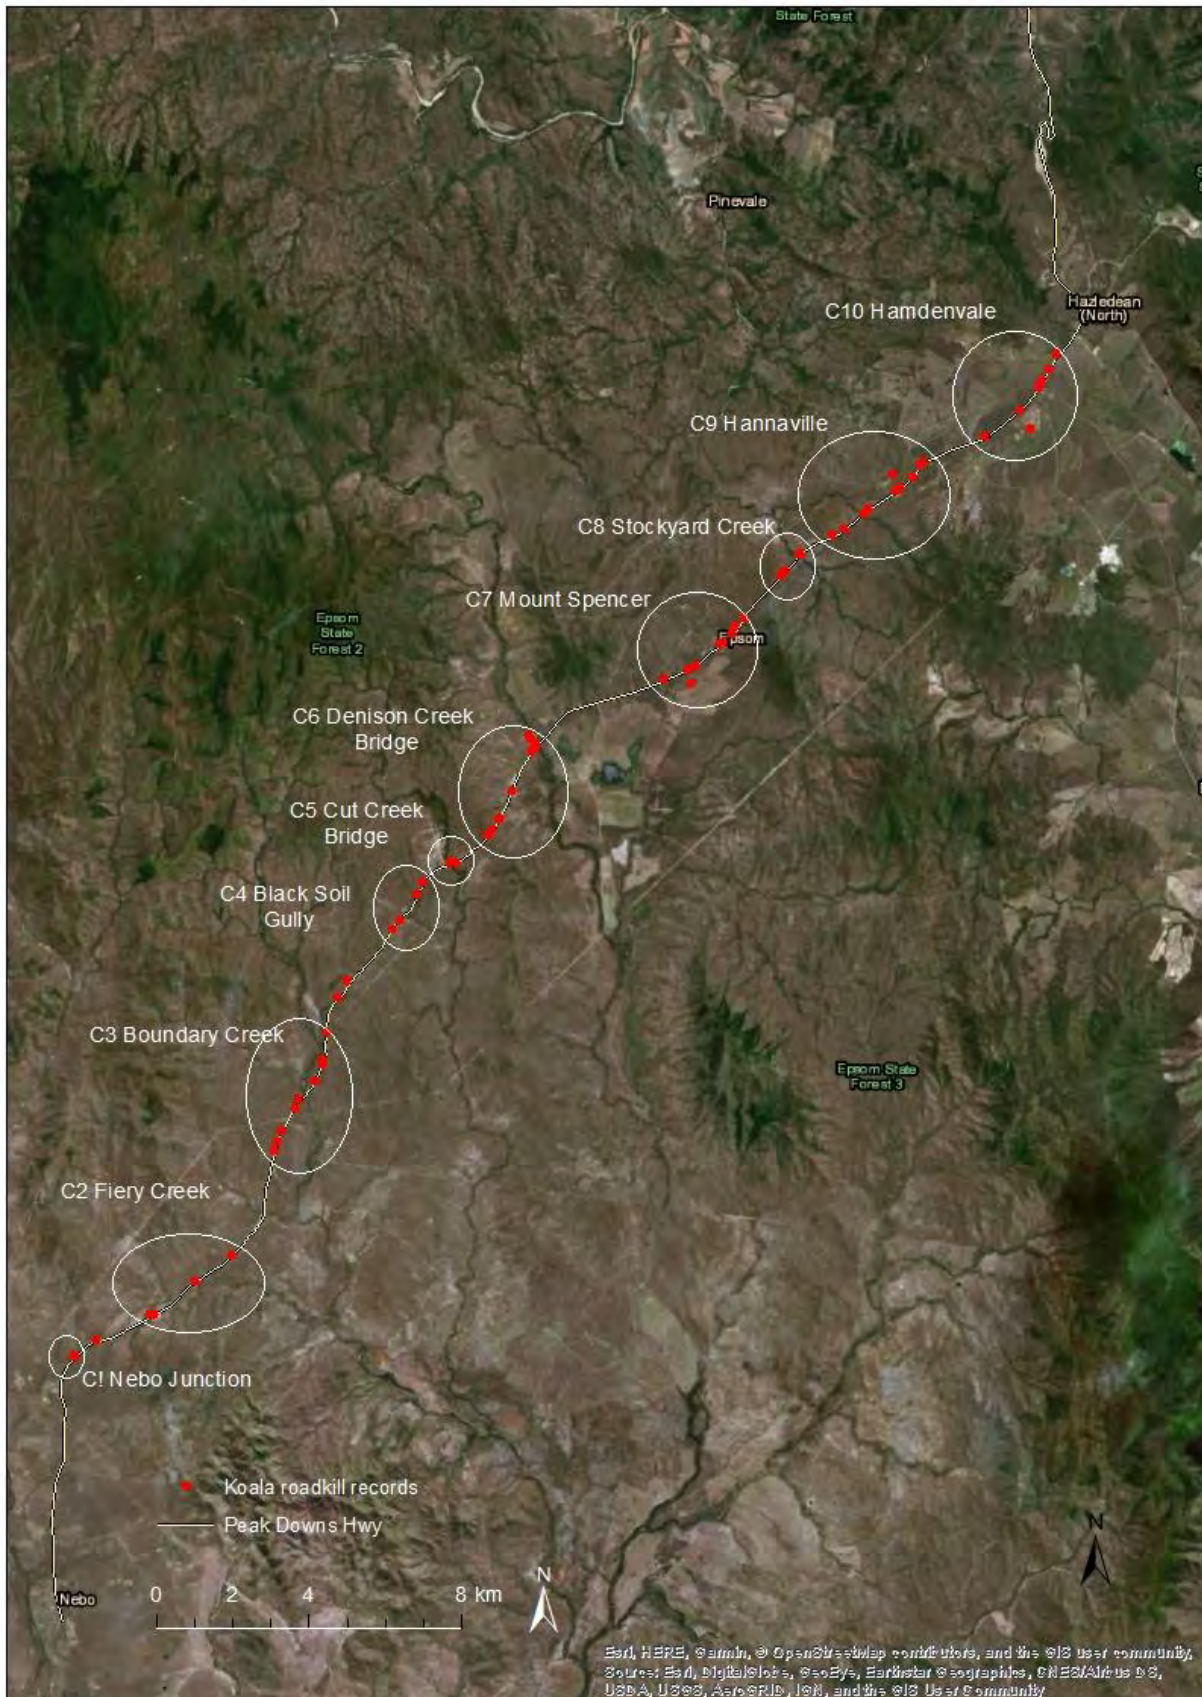
**Figure 1.** Distribution of koala road kills (September 2014 – August 2017) between Nebo Junction and Hazledean on the Peak Downs Highway, Central Queensland. The koala records are shown as red points. The records were unevenly distributed and grouped into 10 clusters with three or more records (white ovals).

The distribution of 69 recorded koala road kills (September 2014 to August 2017) was mapped along the stretch of Peak Downs Highway from Nebo Junction to Hazledean. This was projected onto *Google Earth* to facilitate a tablet-based road survey (Figure 1). Groups of sightings (three or more) were considered a cluster that was then given a name based on a prominent local feature or property. Ten clusters were identified (Table 1). The area between clusters was designated an inter-cluster. With one exception, inter-clusters were free of koala road kills during the sample timeframe.

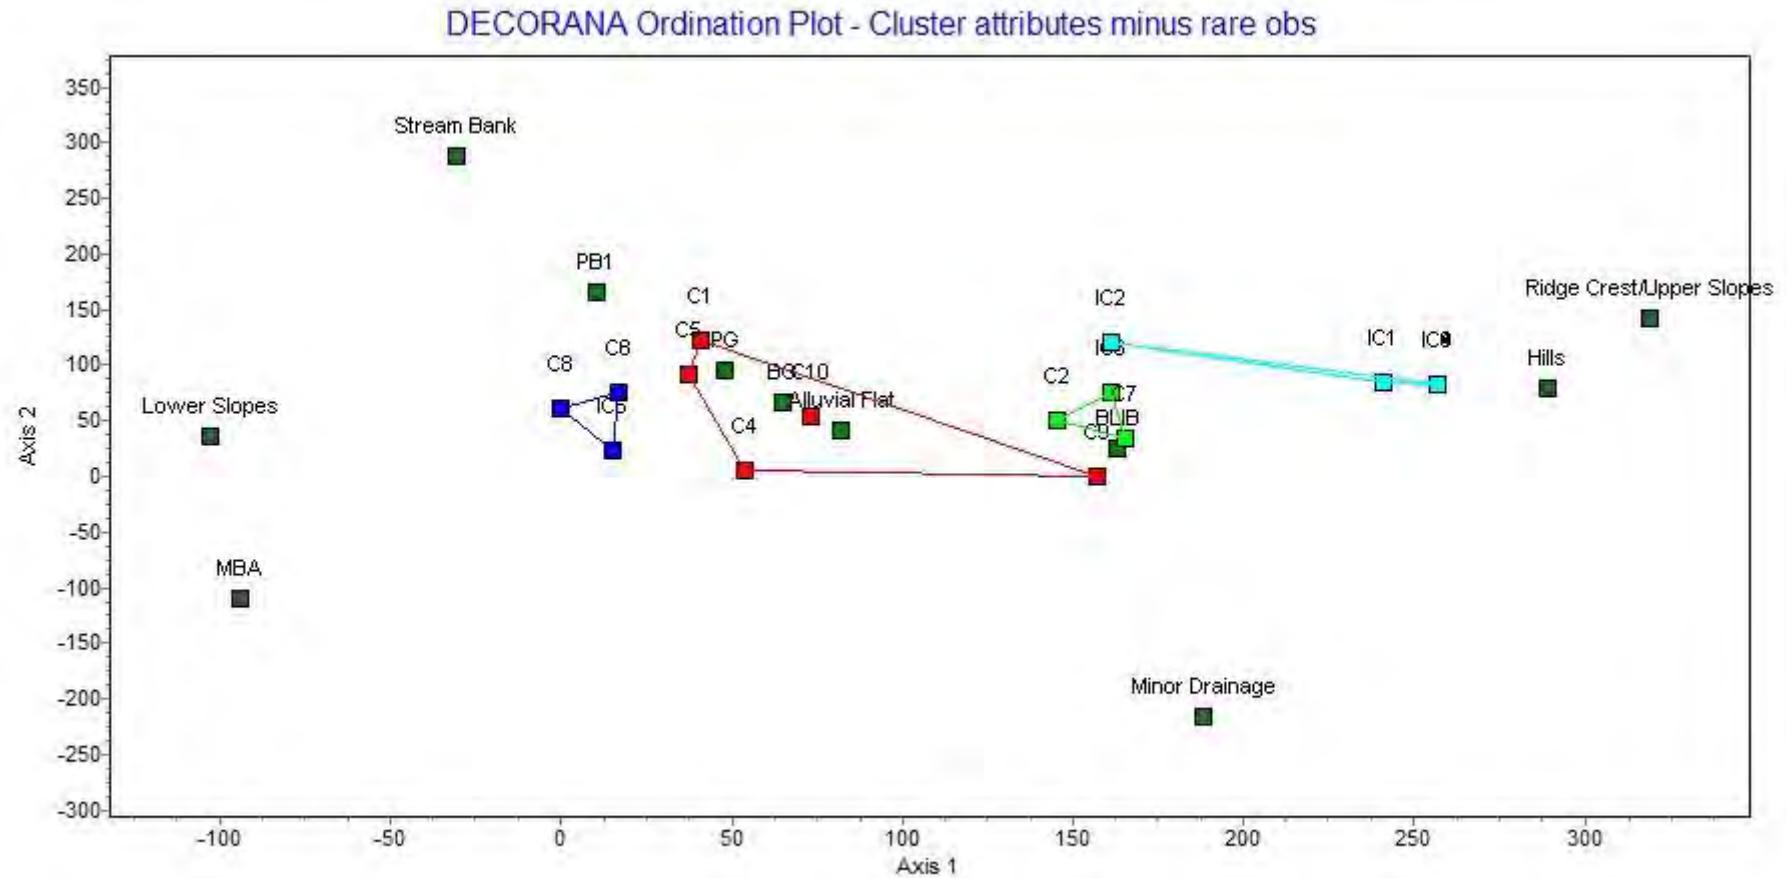
**Figure 3.** DECORANA ordination of cluster and inter-cluster attributes. Axis 1 follows a landform gradient from stream bank and lower slopes (left) to upper slopes, ridge crests and hills (right). The group boundaries, identified in Figure 2, are shown and are arranged, left to right, group 2, group 1, group 3 and group 4. Koala records are associated with groups 1, 2 and 3. There are no records for group 4.

The DECORA ordination arranged the clusters and attributes into a generally horizontal pattern (Figure 3) reflecting a gradient from lowland landform elements and associated tree species (left) to highland elements and tree species (right). The ordination clearly resolved the four groups evident in the dendrogram (Figure 2). Groups 1 and 2 are at the lowest end of the gradient. Group 4 is at the upper end of the gradient. Group 3 is intermediate. Groups 1, 2 and 3 are associated with koala road kills. There are no kills in Group 4. The highest kill records were associated with groups 1 and 2, with lesser counts for Group 3 (Table 4).

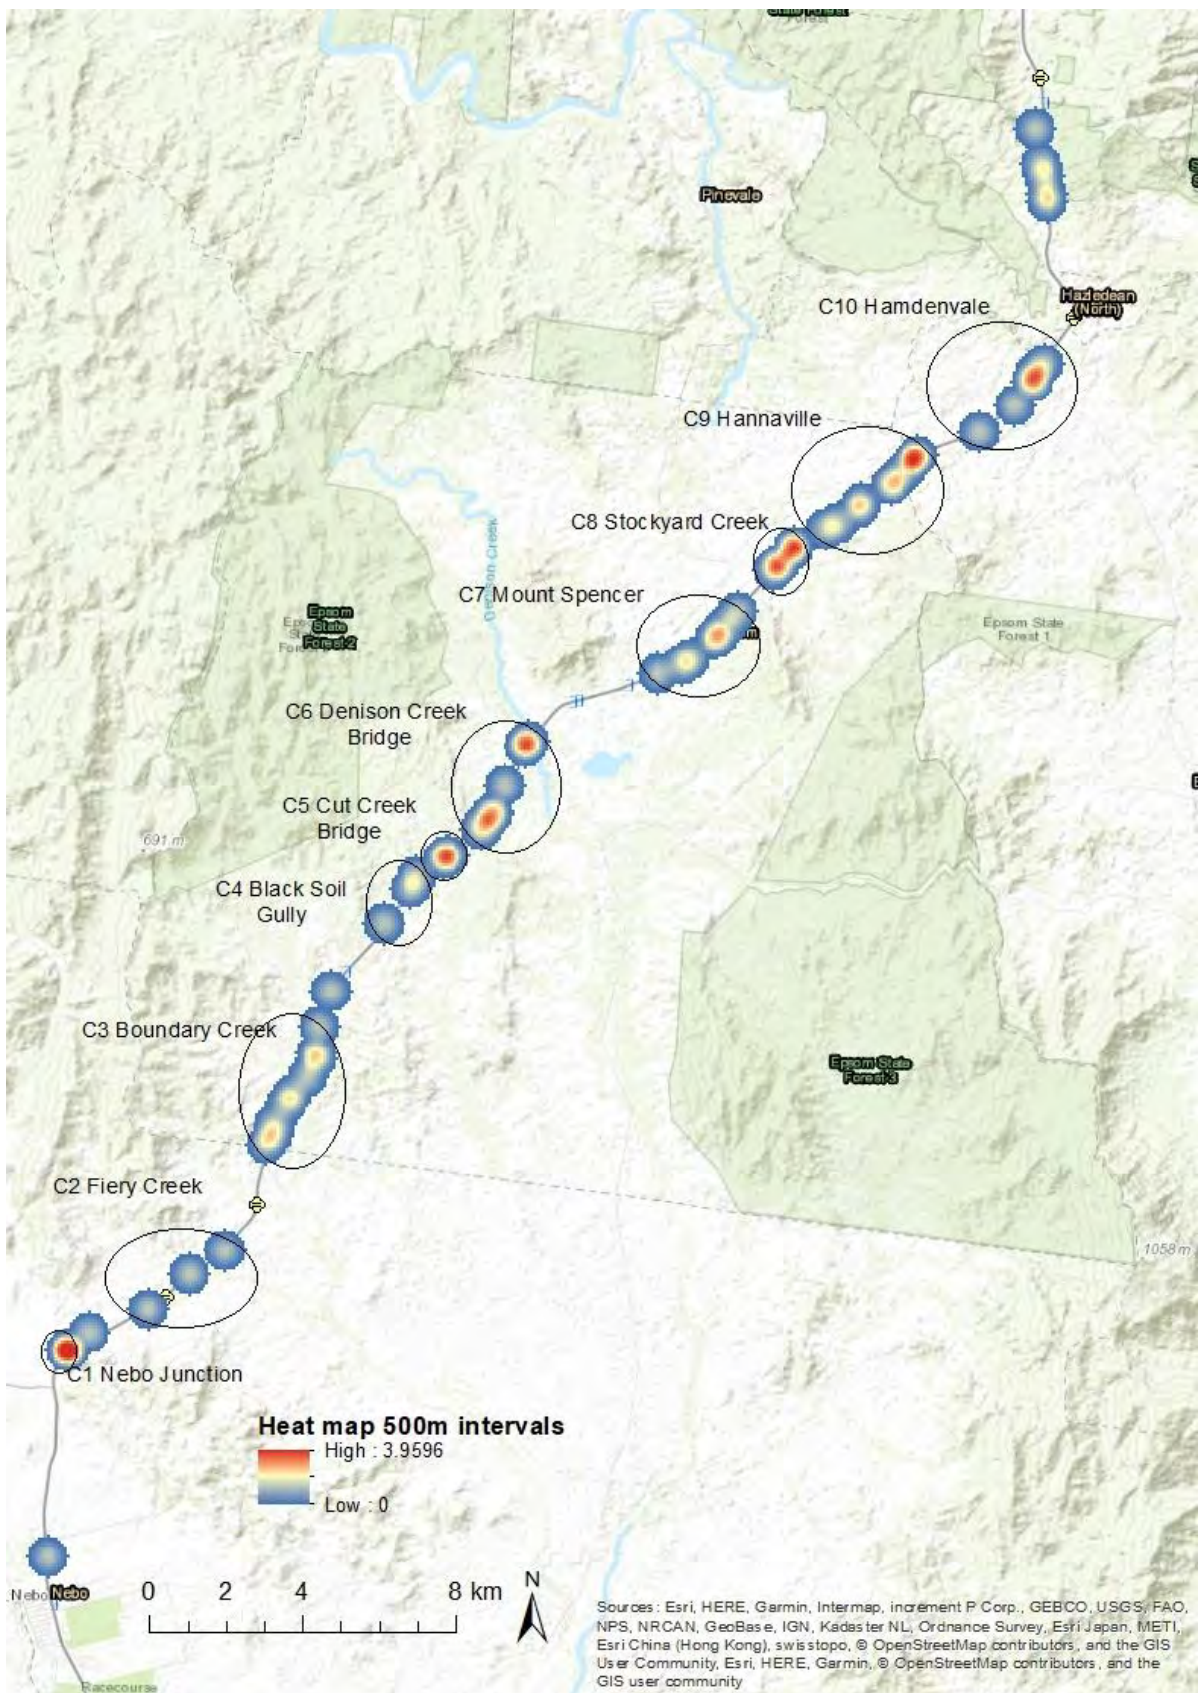
Figure 4. Relationship between the koala clusters and road kill hotspots identified by Schlagloth (2018)

Despite these anomalies, the results provide a basis for on-ground classification of where koala-road interactions are most likely, and hence, provide a guide as to where to focus potential investment in protective infrastructure. There is also a strong accord between the clusters and the hot spots modelled by Schlagloth (2018) (Figure 4).

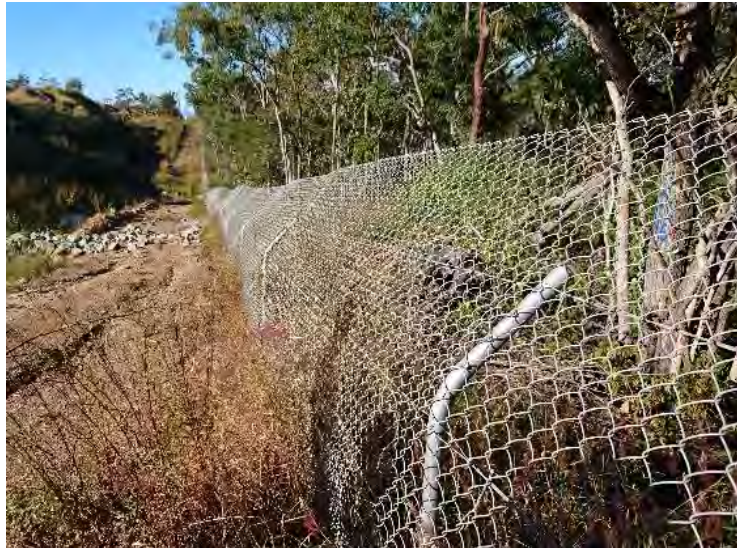
**Figure 6.** Koala barrier fencing erected in association with the upgraded Eton Range upgrade of the Peak Downs Highway.

The distribution of koala sightings across the majority of the Eton to Nebo extent of the Peak Downs Highway precludes the extensive investment in major engineered structures such as additional bridges, underpasses and overpasses. Further, the terrain provides limited, yet well defined opportunities for the locating of such facilities. The protective infrastructure with the most utility over distances, and through variable terrain, is appropriately designed barrier fencing. Such fencing has been installed as part of the Eton Range Realignment Project mitigation works (Figure 6).
