Structure Condition Inspection Report

Name A.J. Bond Bridge

Crossing Name Gilbert River

Date 01-OCT-2009

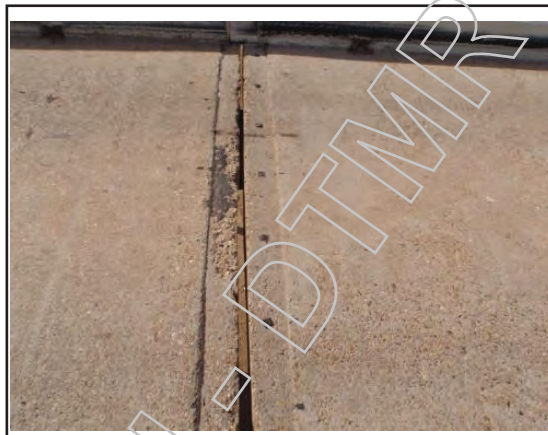
VIEW OF JOINT WITH STEEL PLATE REMOVED

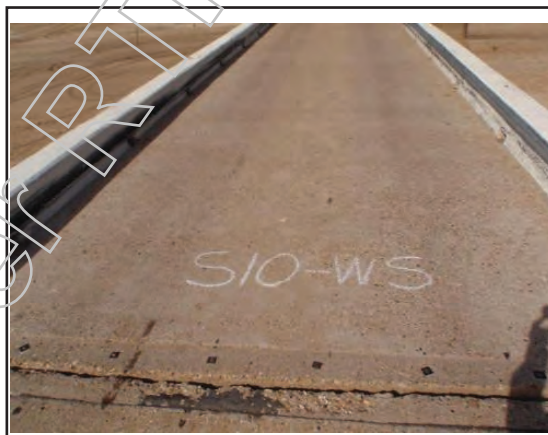
VIEW OF SPAN 10 WEARING SURFACE

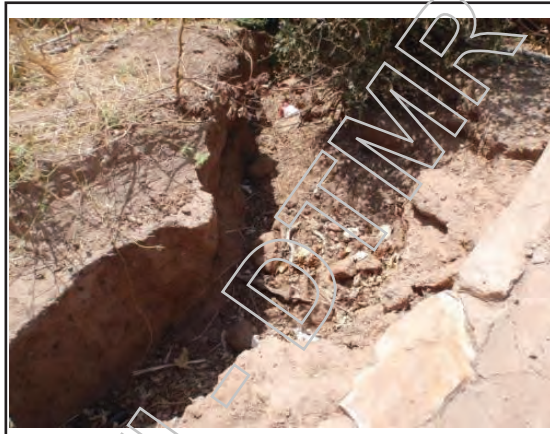
SHOWING LARGE SCOUR INFRONT OF WING WALL SIDE 1

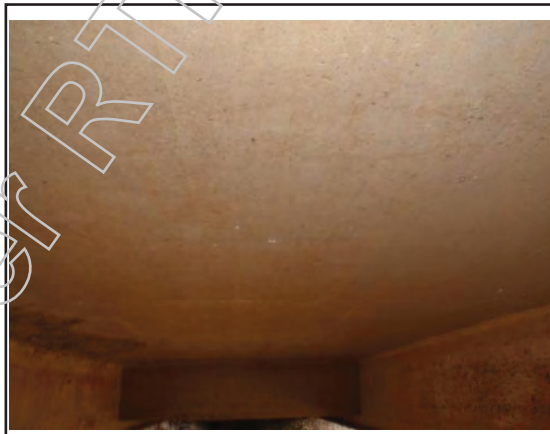
VIEW OF SPAN 1 DECK

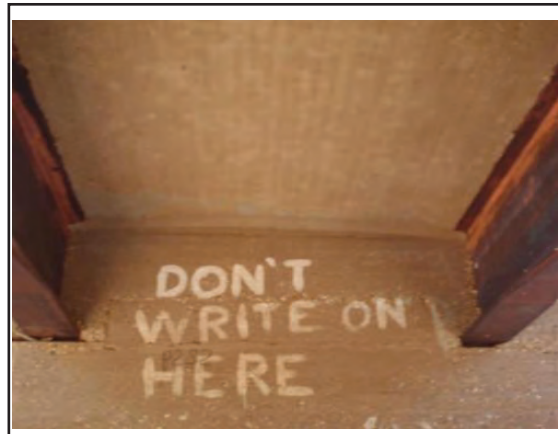
VIEW OF LOAD BEARING XG

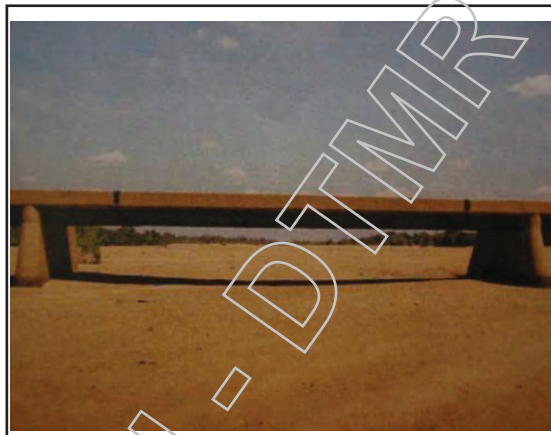
VIEW OF BRIDGE SPAN BETWEEN PIERS

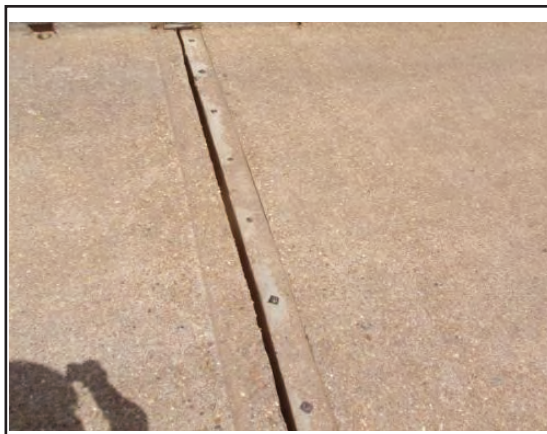
SHOWING REMOVED JOINT COVER PLATE, SIMILAR FOR OTHER

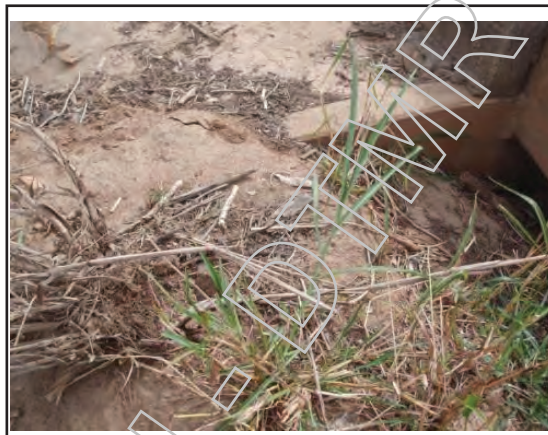
VIEW OF WING BURIED BY SILT, SIMILAR FOR OTHER WING.

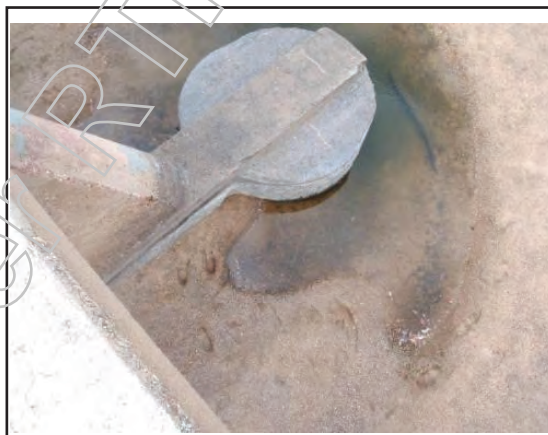
EXPOSED PILE FROM FLOOD

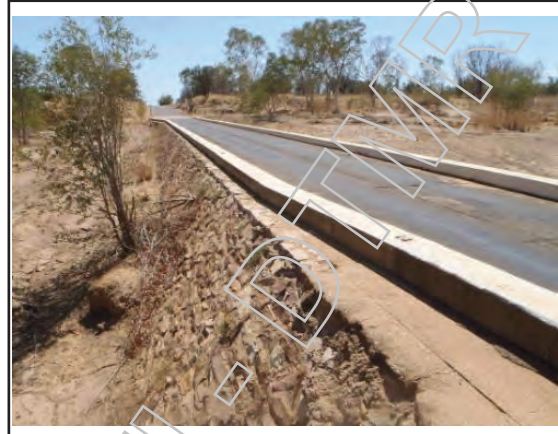
Causeway at AP2

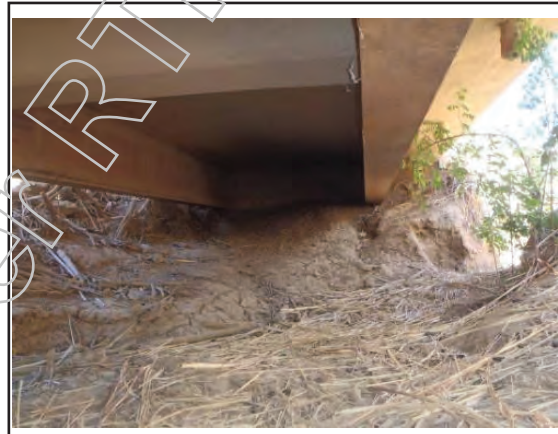
View of A1

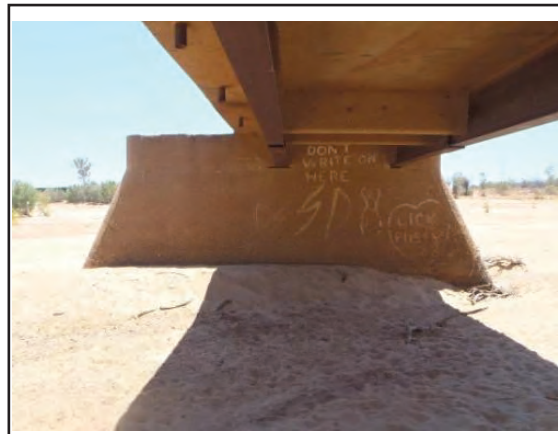
View of P2

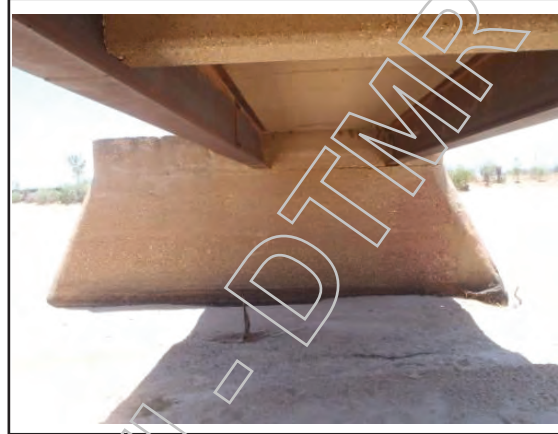
Description
View of P3

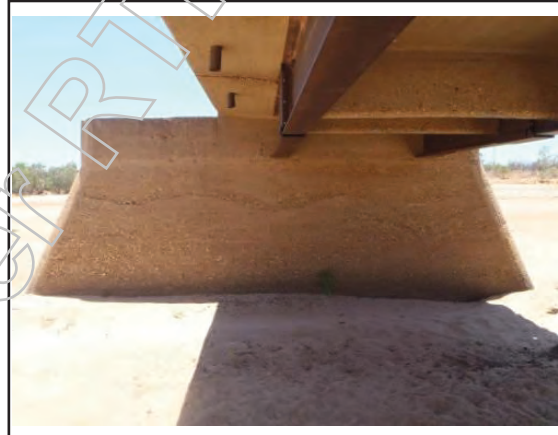
Description
View of P4

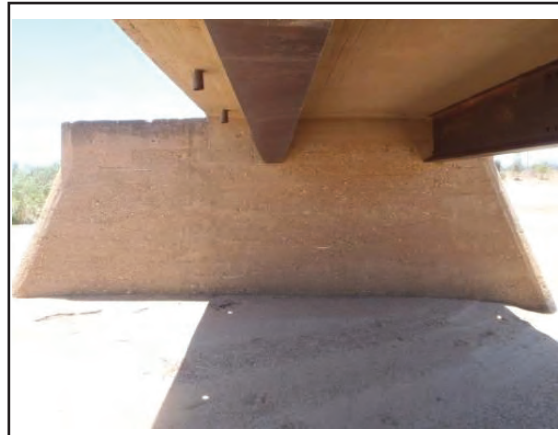
Description
View of P5
